Lower Chicopee River Watershed Stormwater Assessment Project

Final Report
2014-02/604

June 30, 2017

Prepared By Pioneer Valley Planning Commission
Chicopee 4Rivers Watershed Council

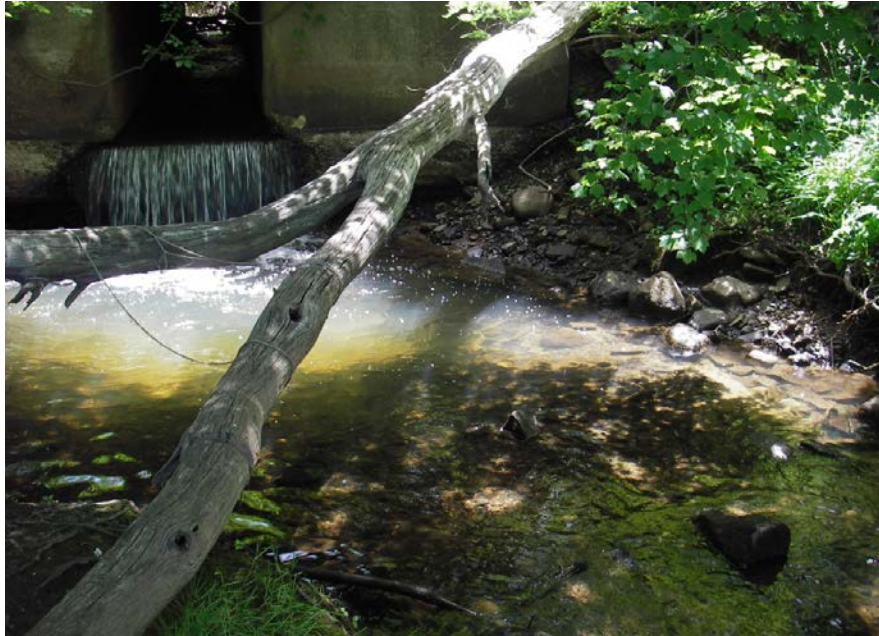
Outfall at Grochmal Avenue that delivers flow to the Chicopee River.

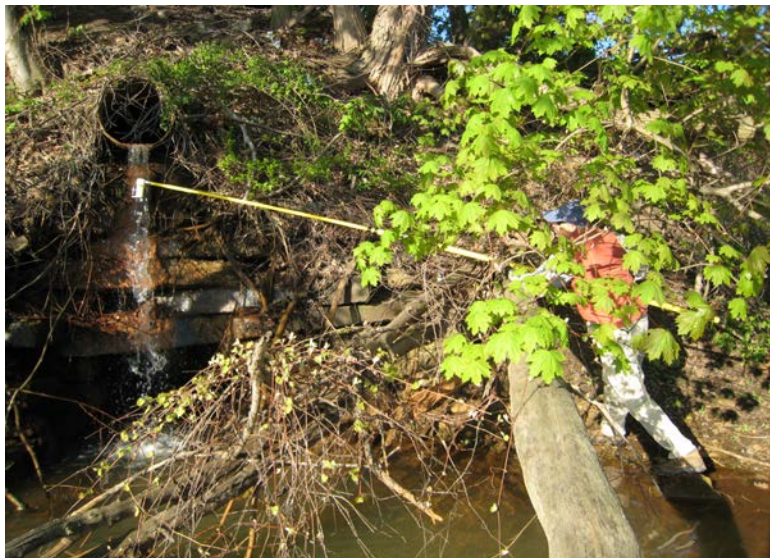
Volunteer Alan Menard reaches to collect a sample at an outfall to the Chicopee River (C08). Getting to this site required permission to walk through the back yard of private property owner at 525 Main Street, Chicopee, and then steep climb down to River's edge.

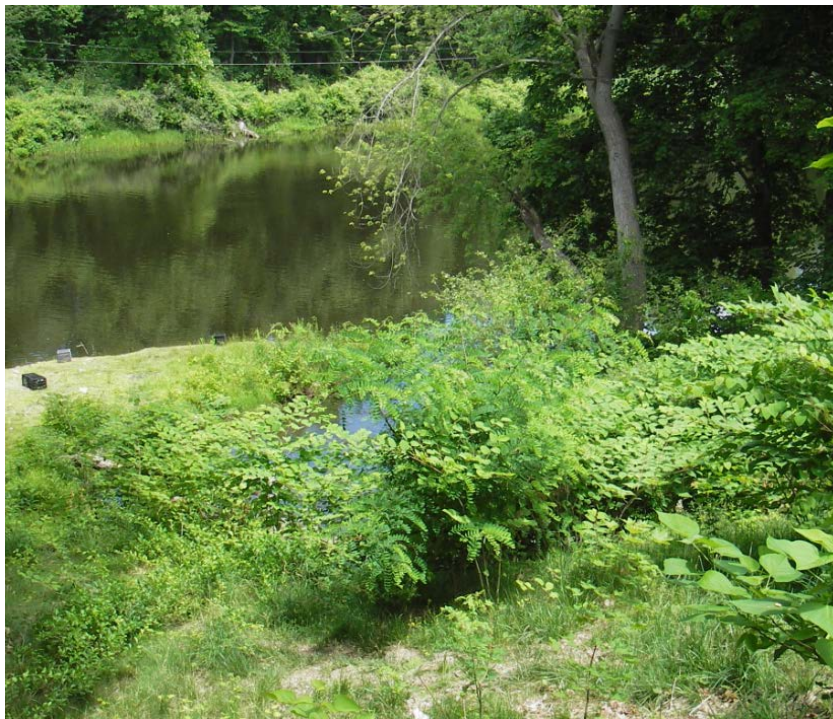
Abbey Brook confluence with the Chicopee River. Just before it reaches this location, Abbey Brook spills out of a highly perched culvert.

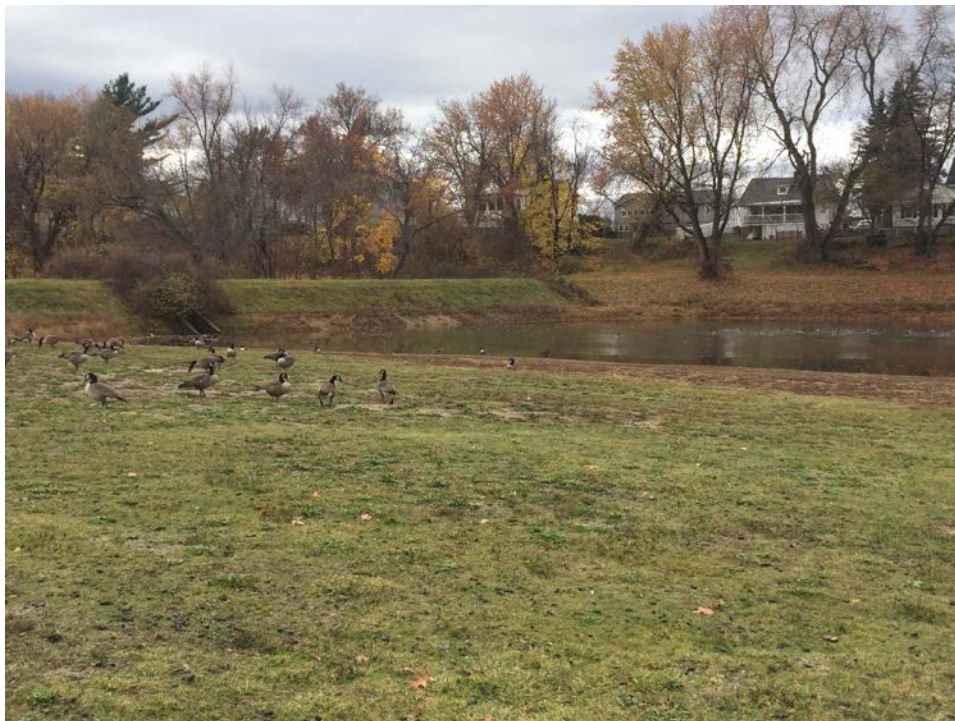
Geese congregate along the shores of Bemis Pond in Szot Park, Chicopee.

E. coli results from these upstream locations, including A01C, were below the threshold for water unsuitable for recreation. That was not the case at A01B, which again had *E. coli* levels above the study threshold. In this round, the site below lower Bemis Pond also had elevated *E. coli* levels. Together these sites suggest that the waste coming from the geese may indeed be a problem.

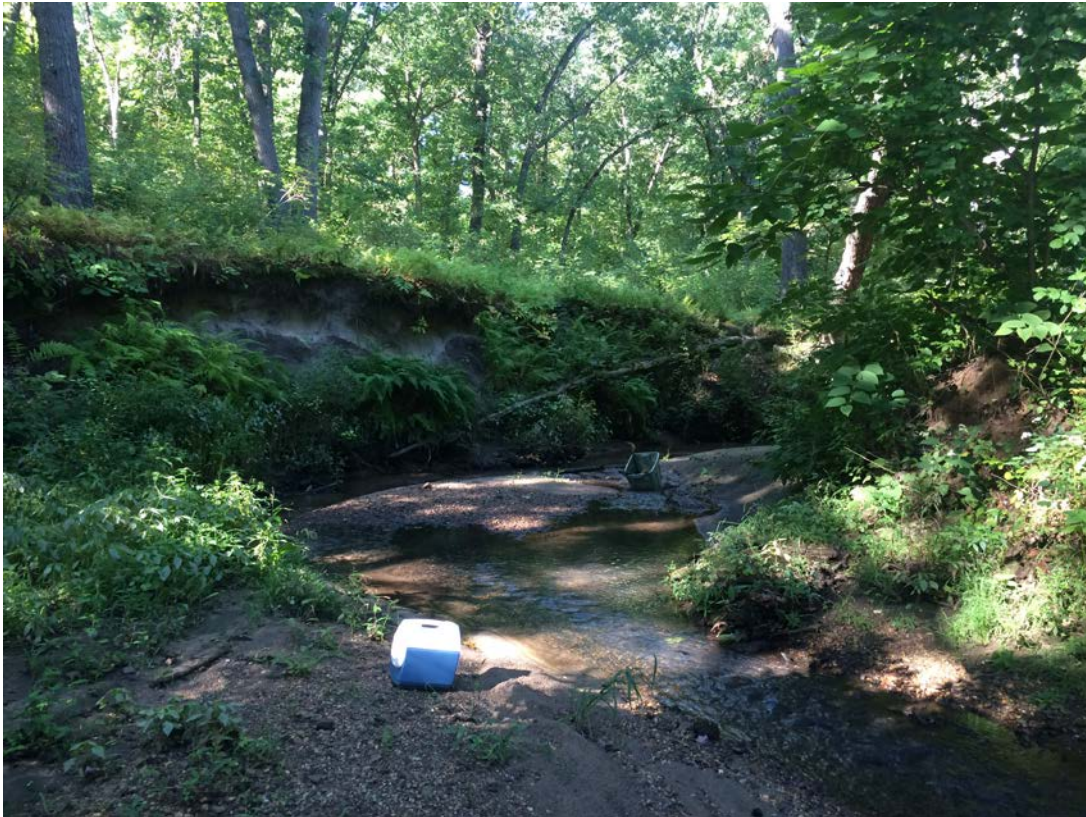
*While the Abbey Brook site at Mildred Avenue (A01E) did not show elevated *E. coli* levels, this upper part of the system is highly impacted from urbanized flows. Sampling at this site on 10/10/16, some 16 hours after a .37-inch storm, it is apparent that the real drama of what happens to this system occurs much closer to the storm event.*
